Manhole Inspection Summary

Manhole # S21EE_011MH

Insp Date: **6/27/07 10:24 AM**

Location Address: **1401 FULTON AVE**

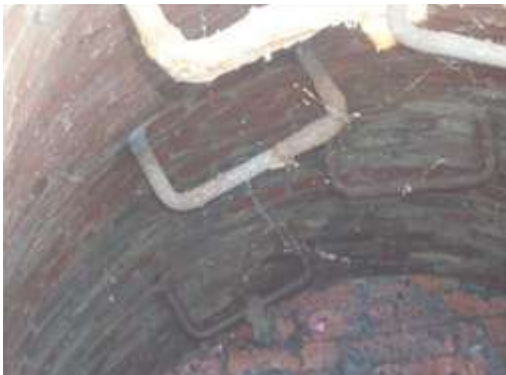
Defect 3

Surcharge ☒ **Evidence Of Surcharge** Depth: **2** (ft.) ☐ Active Surcharge Present

SURCHARGE EVIDENCE ON STEPS

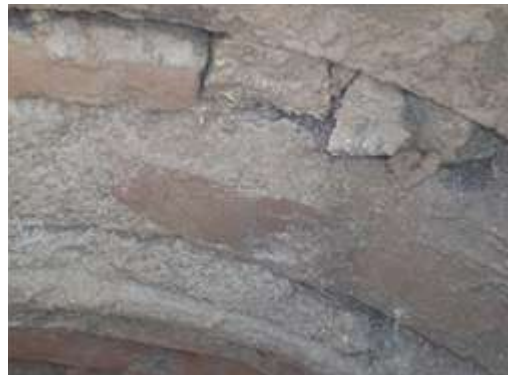
Defect 2

Condition: ☐ Sound ☐ Cracked ☐ Root Intrusion ☐ Loose Brick ☒ **Deteriorated**

DETERIORATION OF CHIMNEY

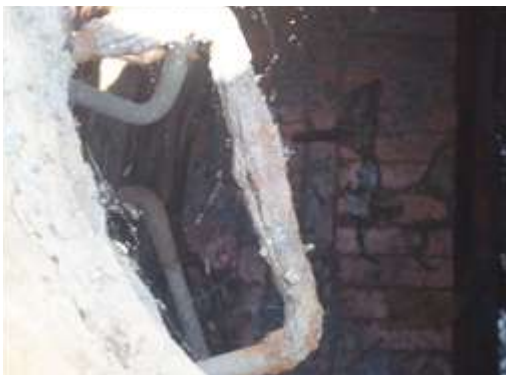
Defect 1

Steps Count: **5** Missing: **0** ☒ **Corroded**

CORRODED STEPS

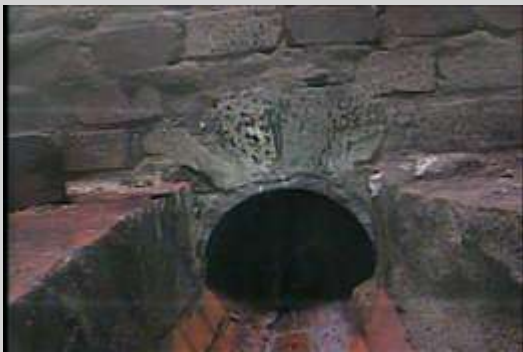
12 O'Clock Outflow

Pipe Height: **8.4** (in.) Rod and Bar (Angled)
Pipe Material: **Clay** ☐ Pipe Lined
Invert Depth: **9.61** (ft.) Flow Characteristics: **Slow**
Deposits: ☒ None ☐ Mud ☐ Sludge ☐ Debris ☐ Grease
Silt Depth: (in.) Deposits Extent:
Infiltration: **None** Pipe Seal Cond: **Sound**

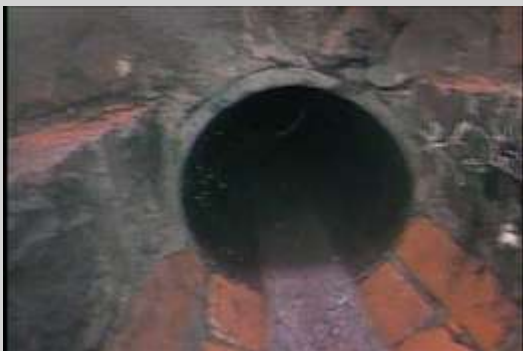
3 O'Clock Inflow

Pipe Height: **8.4** (in.) Rod and Bar (Angled)
Pipe Material: **Clay** ☐ Pipe Lined
Invert Depth: **9.20** (ft.) Flow Characteristics: **Slow**
Deposits: ☒ None ☐ Mud ☐ Sludge ☐ Debris ☐ Grease
Silt Depth: (in.) Deposits Extent:
Infiltration: **None** Pipe Seal Cond: **Sound**

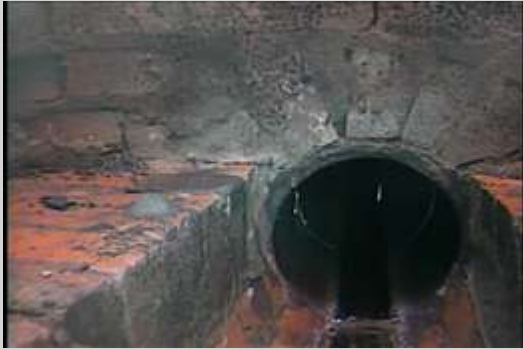
6 O'Clock Inflow

Pipe Height: **8.4** (in.) Rod and Bar (Angled)

Invert Depth: **9.35** (ft.) Flow Characteristics: **Slow**

Infiltration: **None** Pipe Seal Cond: **Sound**
